# Hyperspectral Imaging for Monument Preservation

Case study for a Baroque epitaph in the St. Mary's Church in Frankfurt (Oder), Germany

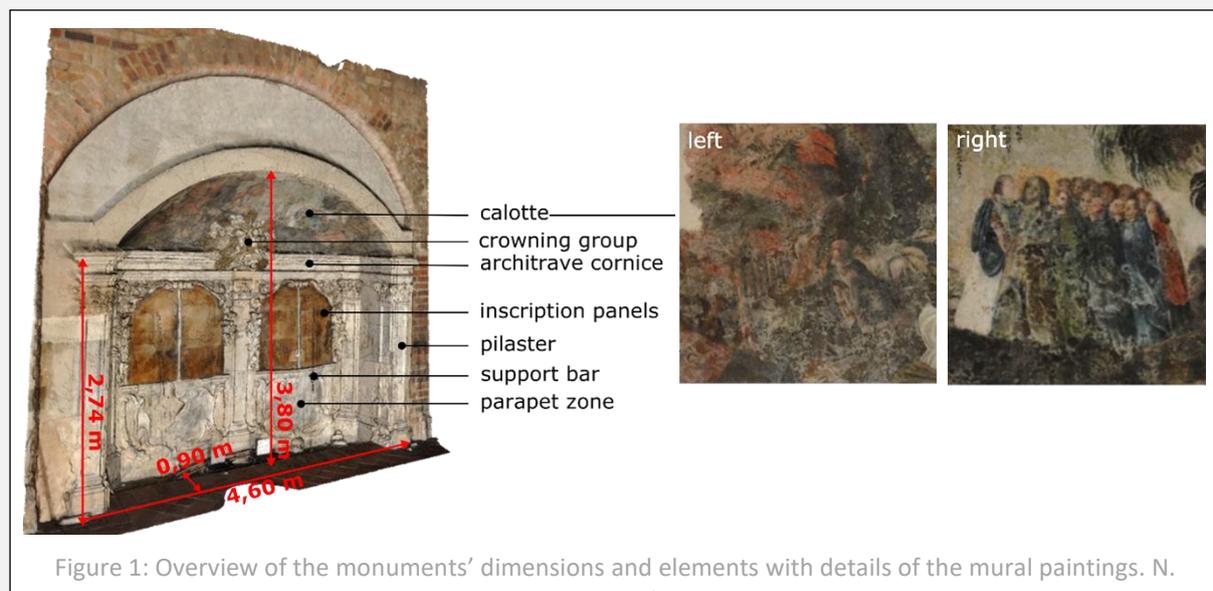
Figure 1: Overview of the monuments' dimensions and elements with details of the mural paintings. N.

The different elements of the burial site are shown in Figure 1. It contains inscription panels framed in fine stucco decoration. The sides are lined by pilasters with Corinthian capitals and the parapet zone below the panels is decorated with stucco motifs of transience such as skulls and bones. Above the pilasters sits a stuccoed crowning group with angels, hourglass and a skull, topped by a calotte with an 18th century mural painting depicting biblical scenes.

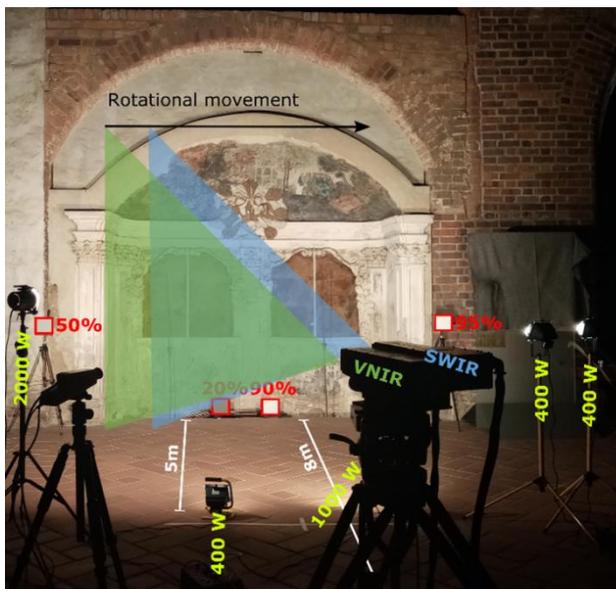
Figure 2: Setup of the HySpex hyperspectral cameras, lamps and showing the field of view and rotational movement of the cameras.<sup>1</sup> Image: N. Köllner

The epitaph was scanned using cameras from the **HySpex Classic** and **Mjolnir** series operating in the VNIR (400-1000nm) and SWIR (970-2500nm) spectral regions with a spectral sampling of 3.3nm and 5.5nm, respectively. They were operated from a motorized moving stage, scanning line-by-line in a rotational manner (Fig. 2). Five construction spotlights totaling 5200W were distributed over the entire length of the site at a distance of 5m. Four gray **reference plates** of different reflectivity values were placed in the scene for reflectance retrieval. Distinguishable materials on the surface were also sampled with a point spectrometer and compiled into a reference spectral library. More details on the scanning and correction of the illumination can be found in Köllner et al, 2021.<sup>1</sup> The data analysis was performed by the **GFZ hyperspectral geology** group around Nicole Köllner in cooperation with the **University of Applied Science Potsdam** in the Department of Conservation and Restoration.

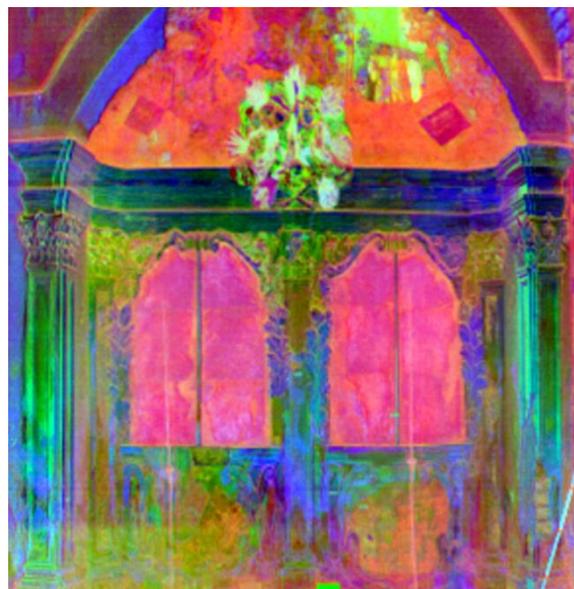
Figure 3: RGB representation of the PCA from components 1-5-8.<sup>1</sup> Image: N. Köllner

Initial information about the spectral differences of the building materials is provided by a **principal component analysis (PCA)**. Fig. 3 shows the result as a color composite of the main components R: 1, G: 5 and B: 8 in the near to short wavelength infrared based on the co-registered HySpex data set. Identical colors within the image represent spectrally homogeneous surfaces. The high spectral variance of the stucco ornaments is particularly striking here. During the conservation measures between 1983 and 1985, the lime stucco ornamentation was restored, and the outcroppings were largely supplemented by hand.<sup>3</sup> Presumably, these differ spectrally from the original lime stucco.

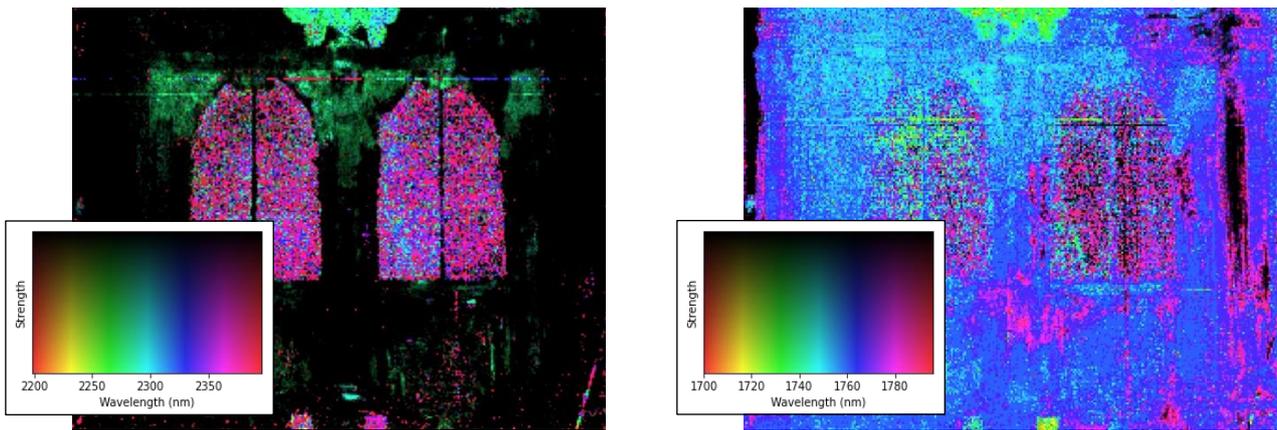
Figure 4. Representation of the spectral fingerprints by the depth and position of their respective absorption feature in the shortwave infrared. Left: Stucco elements, Right: Gypsum.<sup>1</sup> Feature adapted after Nicole Köllner<sup>1</sup>.

Spatial distribution maps for minerals, mineral groups and moisture can be generated by isolating the respective, known absorption features and **calculating their absorption band position and depth**. Two different minerals are mapped in Figure 4. Calcite with an absorption feature around 2320-2340nm and gypsum with its diagnostic feature around 1751nm, 2200nm and 2270nm. The carbonate absorption feature was calculated over a larger spectral range (2200-2400nm) as lime stucco may contain gypsum, aggregates and other binders in addition to carbonate components causing a shift in absorption feature position.

The spectral differences of the lime stucco (Fig. 4, right) highlights the compositional change in the supplemented vine ornaments (lateral frame of the panels, no feature), that deviates from the original stucco version (above the inscription panels, bright green). In the parapet zone in the base of the tomb, the formerly strongly sculptured lime stucco ornamentation has largely deteriorated or eroded. The gypsum absorption feature (Fig. 4, left) is pronounced on all plastered surfaces with no or missing color finish, excluding only the lateral supplemented vine ornaments. Changes in absorption position in the area of the crowning group results from differences in stucco mixture.
